## Restoring Drakes Estero: A Journey Back to Eelgrass

by Allison G. Kidder

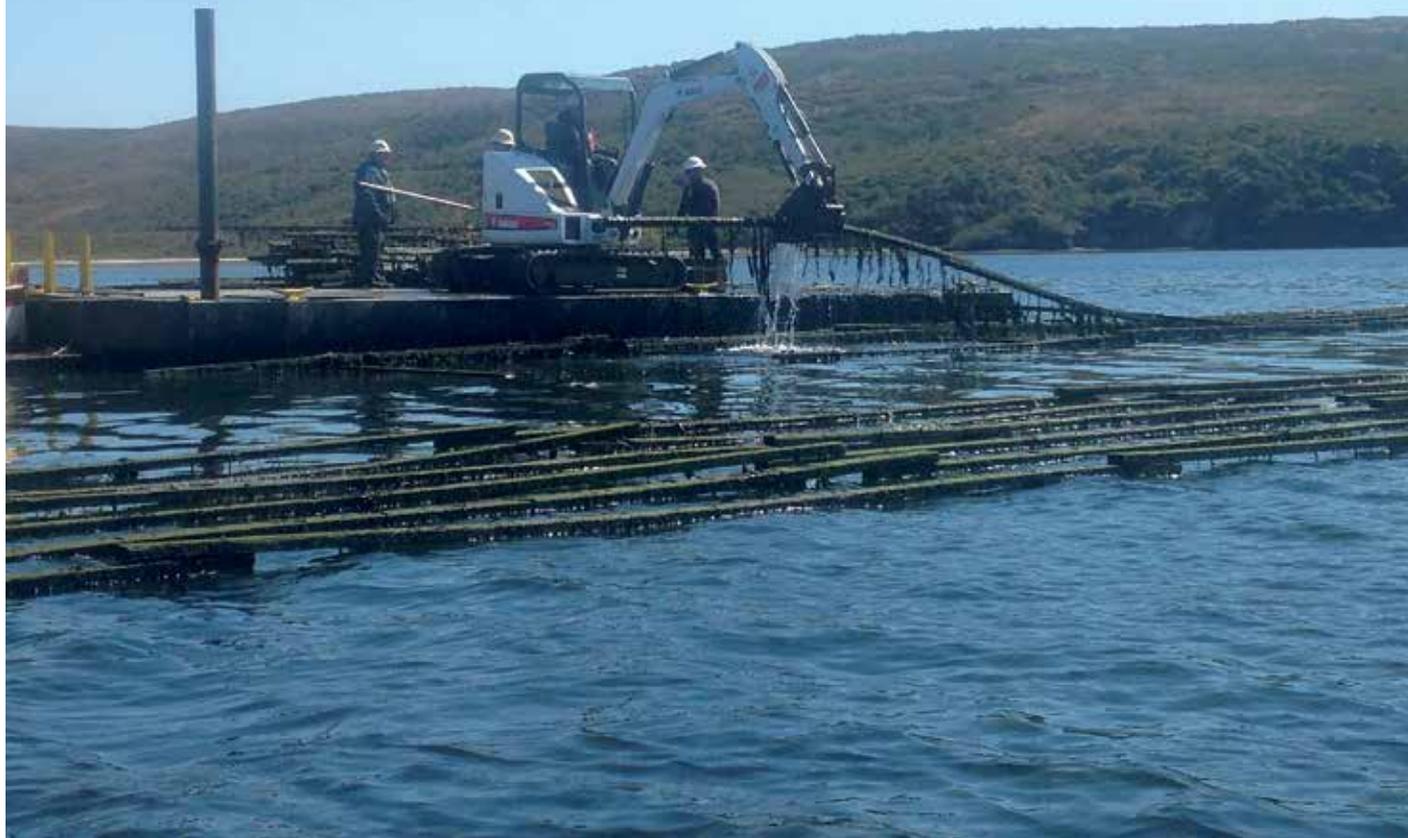
An excavator, precariously balanced on a floating barge, removes wood oyster racks from Drakes Estero in Point Reyes National Seashore, September 14, 2016.

tons of plastic debris, PVC pipe, metal rebar, cement blocks, and shell debris were removed from the estuary. Excavators perched on floating barges removed about 7,000 wooden posts buried five feet deep in the mud and retrieved debris from the bottom where there was no eelgrass. Divers removed the rest by hand in areas where eelgrass was growing.

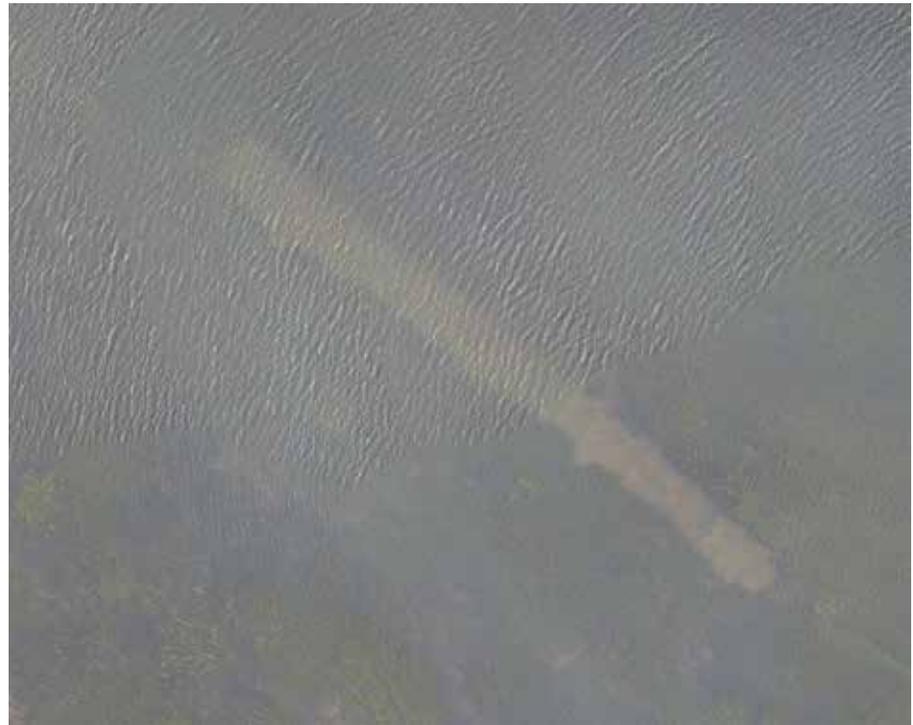
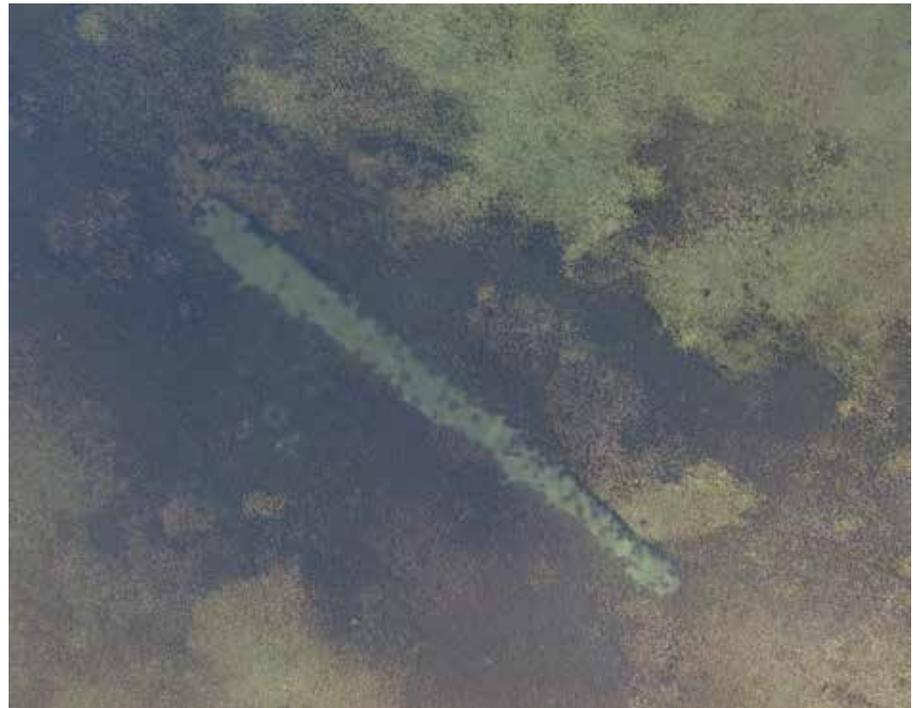
These two photos show an area of Drakes Estero where rectangular oyster racks were removed. The top photo was taken shortly after rack removal and the bottom photo is the same area one year later. The eelgrass has already begun repopulating the vacated floor of Drakes Estero.

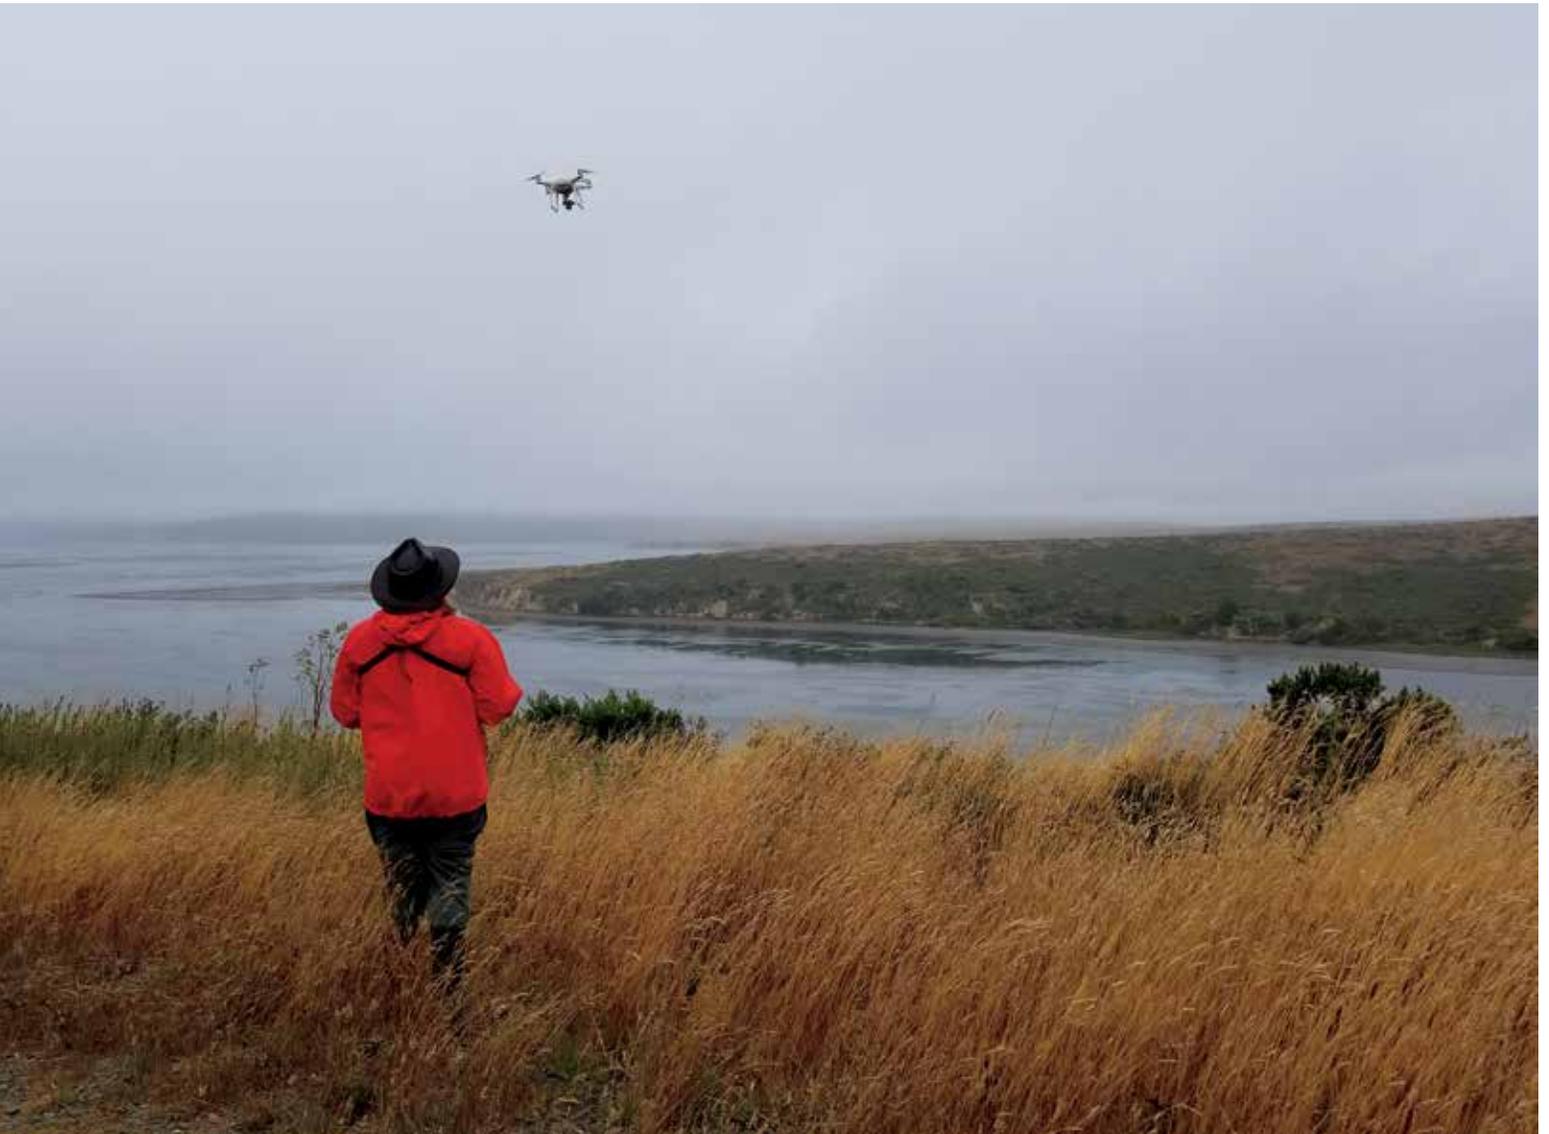
Tom Bell, of Earth Research Institute at University of California Santa Barbara, flies a drone over Drakes Estero in Point Reyes National Seashore to document changes in eelgrass coverage after the removal of oyster racks.

aerial imagery of Drakes Estero using a three-pound, four-propeller DJI Phantom 4 Pro drone. They flew several sets of flights over the restoration area during 2017 and 2018 and will complete at least one set of flights in 2019 with the goal of photographing the entire Estero once per year, and individual bays within the Estero two or three times per summer, one square kilometer at a time.

As long as the sun angle and tide and wind conditions cooperate, their imagery allows them to look at eelgrass recolonization into the restoration areas and document how the eelgrass populations change between years and within years. Making use of the fact that eelgrass reflects light differently and is more structurally complex than nearby wet sand and water, the researchers have just begun a painstaking pixel-by-pixel analysis of their images in order to develop a computer algorithm that will

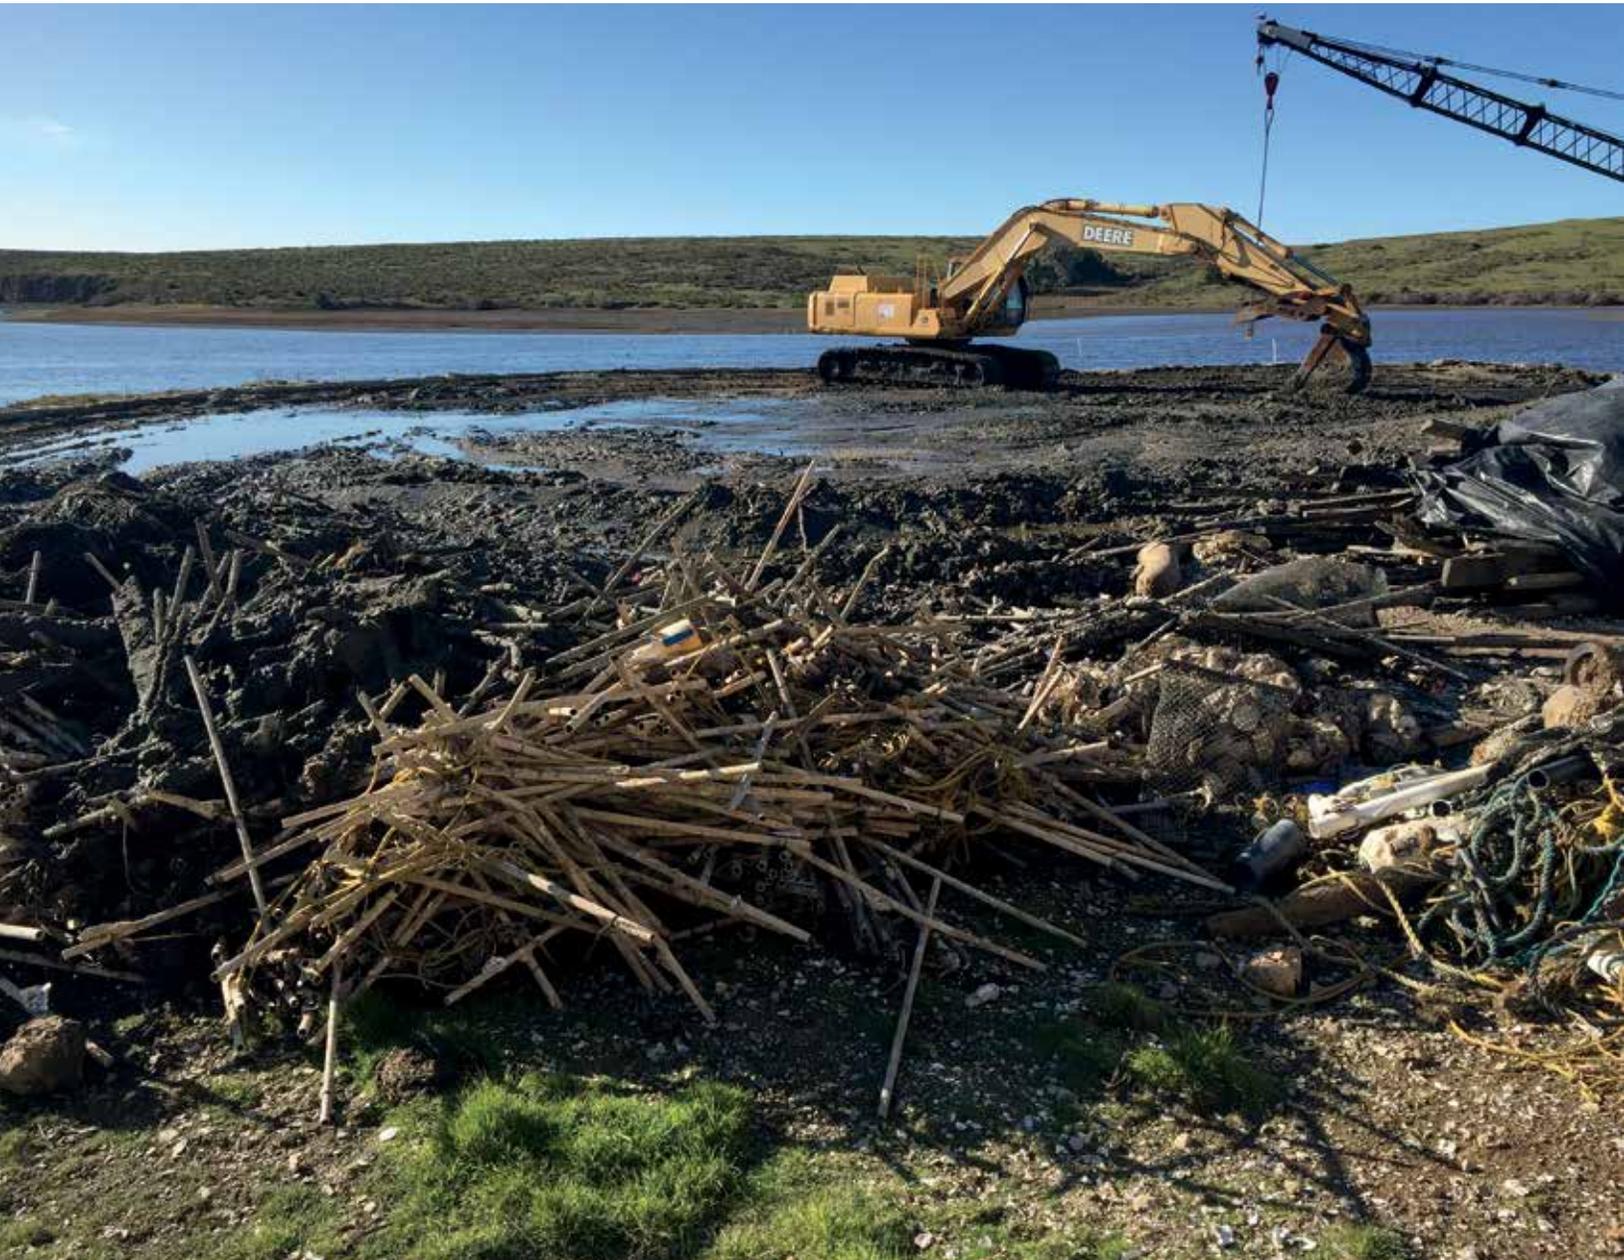
A growing pile of French tubes and other debris removed from Drakes Estero in Point Reyes National Seashore sits in the foreground, with a large excavator in the background, (January 5, 2017).
